# DEPARTMENT OF CONSERVATION

## OFFICE OF MINE RECLAMATION

## OMR Environmental Hazard Remediation & Reclamation Projects

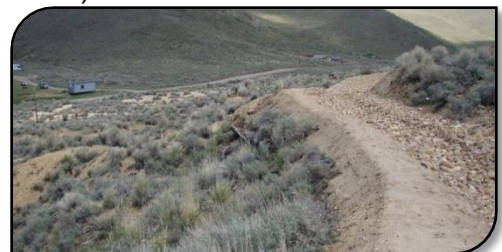
A lined diversion ditch (right side of photo) prevents runoff from eroding mine tailings.

- Installed a modified radon extraction system to reduce mercury vapor concentrations inside the Standard Mill and remediated lead-contaminated soil on slope below the Mill (placed filter fabric and clean fill, revegetated slope, and installed fences to reduce disturbance).
- Remediated lead-contaminated soil from Bell and Rose Klyps Assay buildings (removed top foot of soil in and around buildings; replaced soil with clean fill).
- Removed lead contaminated dust in Wheaton-Hollis Hotel using a HEPA vacuum.
- Controlled erosion of mine tailings adjacent to Bodie Creek by building a diversion channel lined with rocks collected onsite to carry runoff away from the tailings, by constructing weirs in the creek to slow stream flows, and by composting and revegetating the tailings to promote growth of native plants.

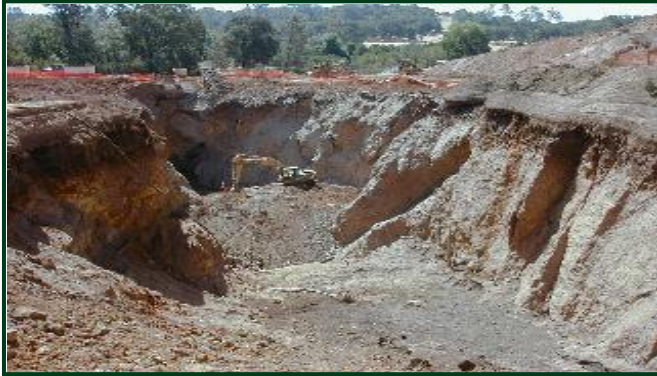
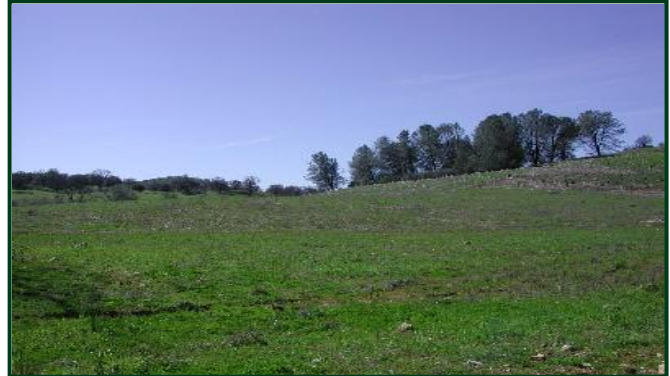
## Spenceville Mine, Nevada County

### BEFORE

### AFTER

Spenceville Mine was a copper mine that operated from 1875 through 1918. Problems with the abandoned open-pit mine included acid mine drainage (AMD) and the forming of an open pit lake in the abandoned mine workings. The mine water had a pH of about 2.5 with elevated levels of iron, copper, and zinc. During high precipitation, water from the pit overflowed into Little Dry Creek, which is under the jurisdiction of the Department of Fish and Game (DFG). Under contract with DFG, OMR developed a strategy to mitigate the AMD and reclaim the mine site to a safe and stable condition. OMR's objective was to identify and select a low-cost, low-maintenance treatment strategy that would: (1) prevent future discharges to state waters by cleaning up and containing AMD and associated heavy metal problems onsite; (2) provide a stabilizing vegetative cover; and (3) meet Central Valley Regional Water Quality Control Board (RWQCB) requirements. OMR's contract work included three phases:
